Jamaica's Susceptibility to Hazards

Geospatial Data - Case Study : Annotto Bay Urban Area Hazard Assessment

Objective: Multi hazard Risk assessment for the Annotto Bay .

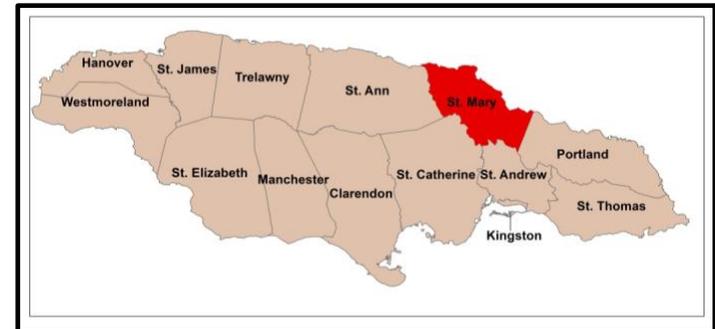
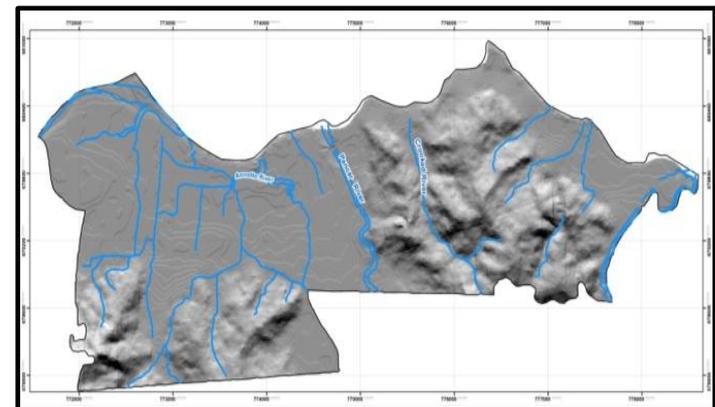
Annotto Bay, St. Mary

- Coastal town located on Jamaica's NE coast
- Low lying – elevations of 1-3m above sea level
- Community is traversed by 4 rivers- Annotto, Pencar, Mother Ford Drain, Crooked Rivers.
